## Pallet deck issues payload damage from protruding nails

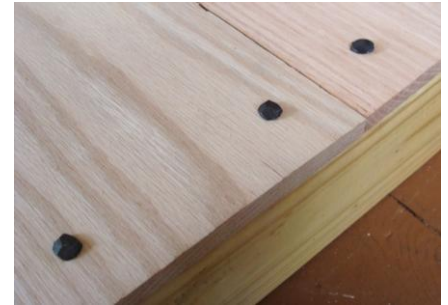
Occasionally product damage arises either from acute product sensitivity to splinters, or protruding nail heads usually due to errors in deck assembly. With any customer complaint always check the significance of damage in terms of numbers since only one or two pallets may generate a complaint, do not condemn a whole batch or a particular design. Avoid this by only shipping nail-flush pallets or with visible overdriving.

The typical target for pallet manufacturers is summed up by the CP1 to CP9 specifications as follows: *Fasteners shall not protrude above the surface of the board. Nail heads shall be countersunk (overdriven) between 2 and 4 mm below the surface of the board.* In subsequent remedial action should this not be met, their proposal is that - *protruding nails should be hammered flush.* However, recognise that is often not possible with larger nails after drying has taken place.
